Cutaway of HG09 Spray Gun

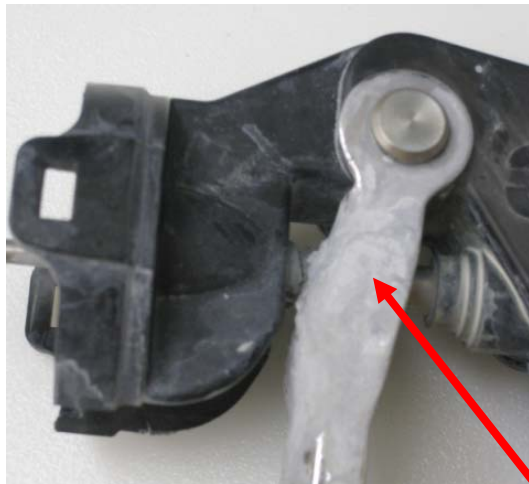
Buildup of primer on Needle due to a failure of seal in Atomizing Head

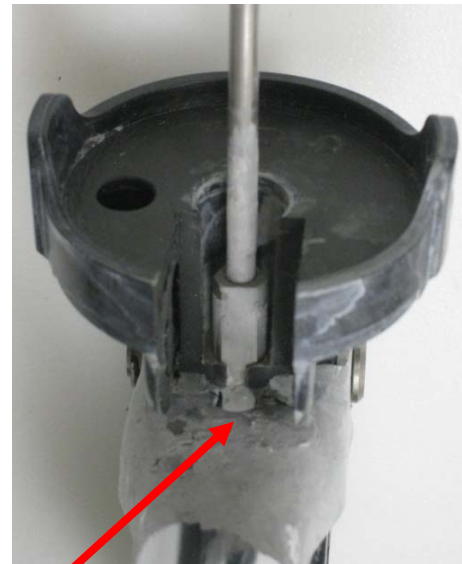
Leaking of material due to a failure of seal In Atomizing Head

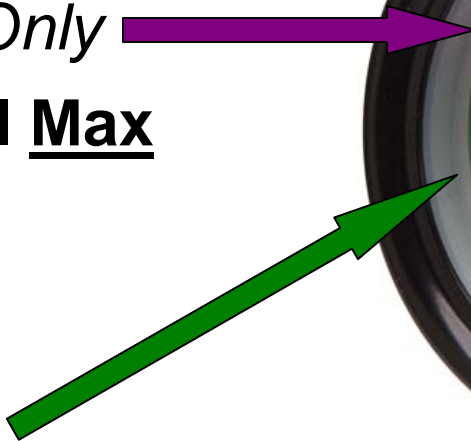
First Stage **Purple**

Air Only

30 PSI Max

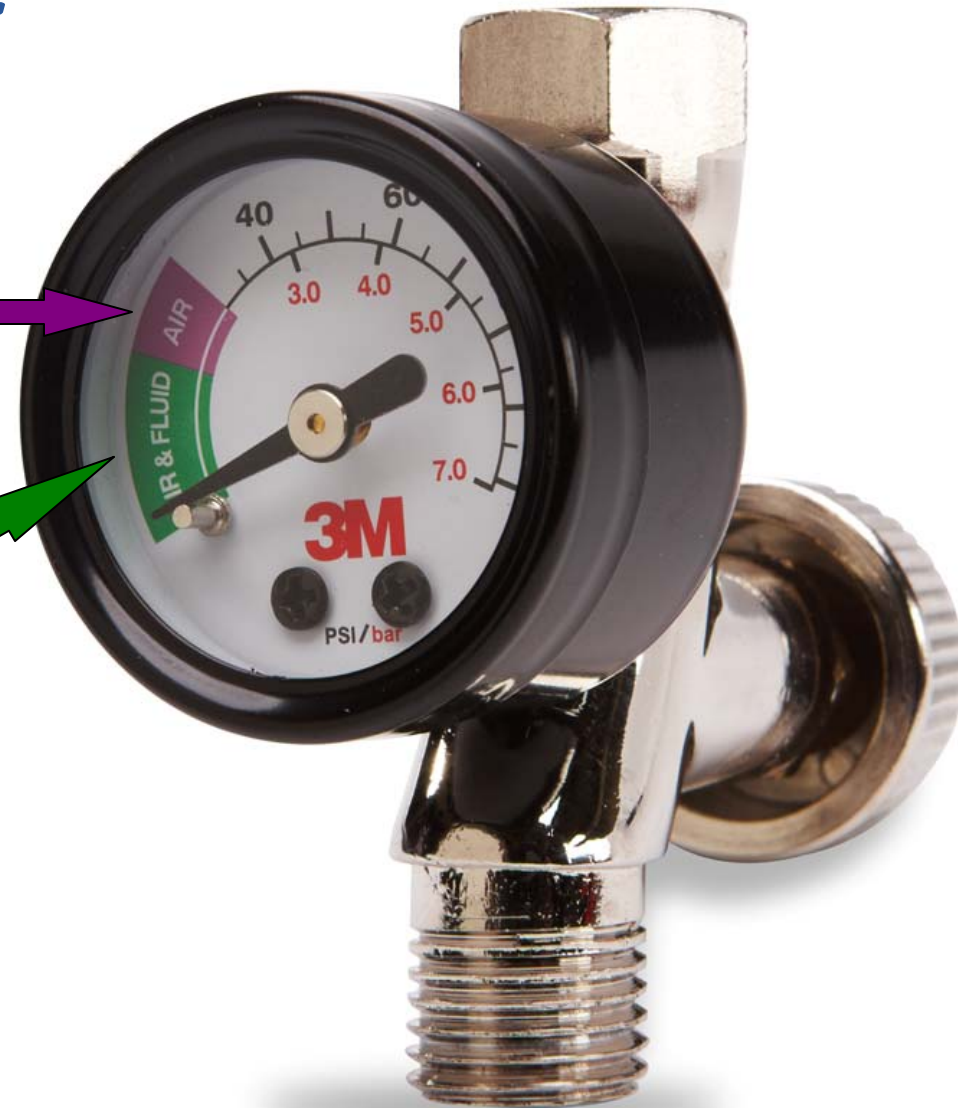
Second Stage **Green**

Air and Fluid

20 PSI Max

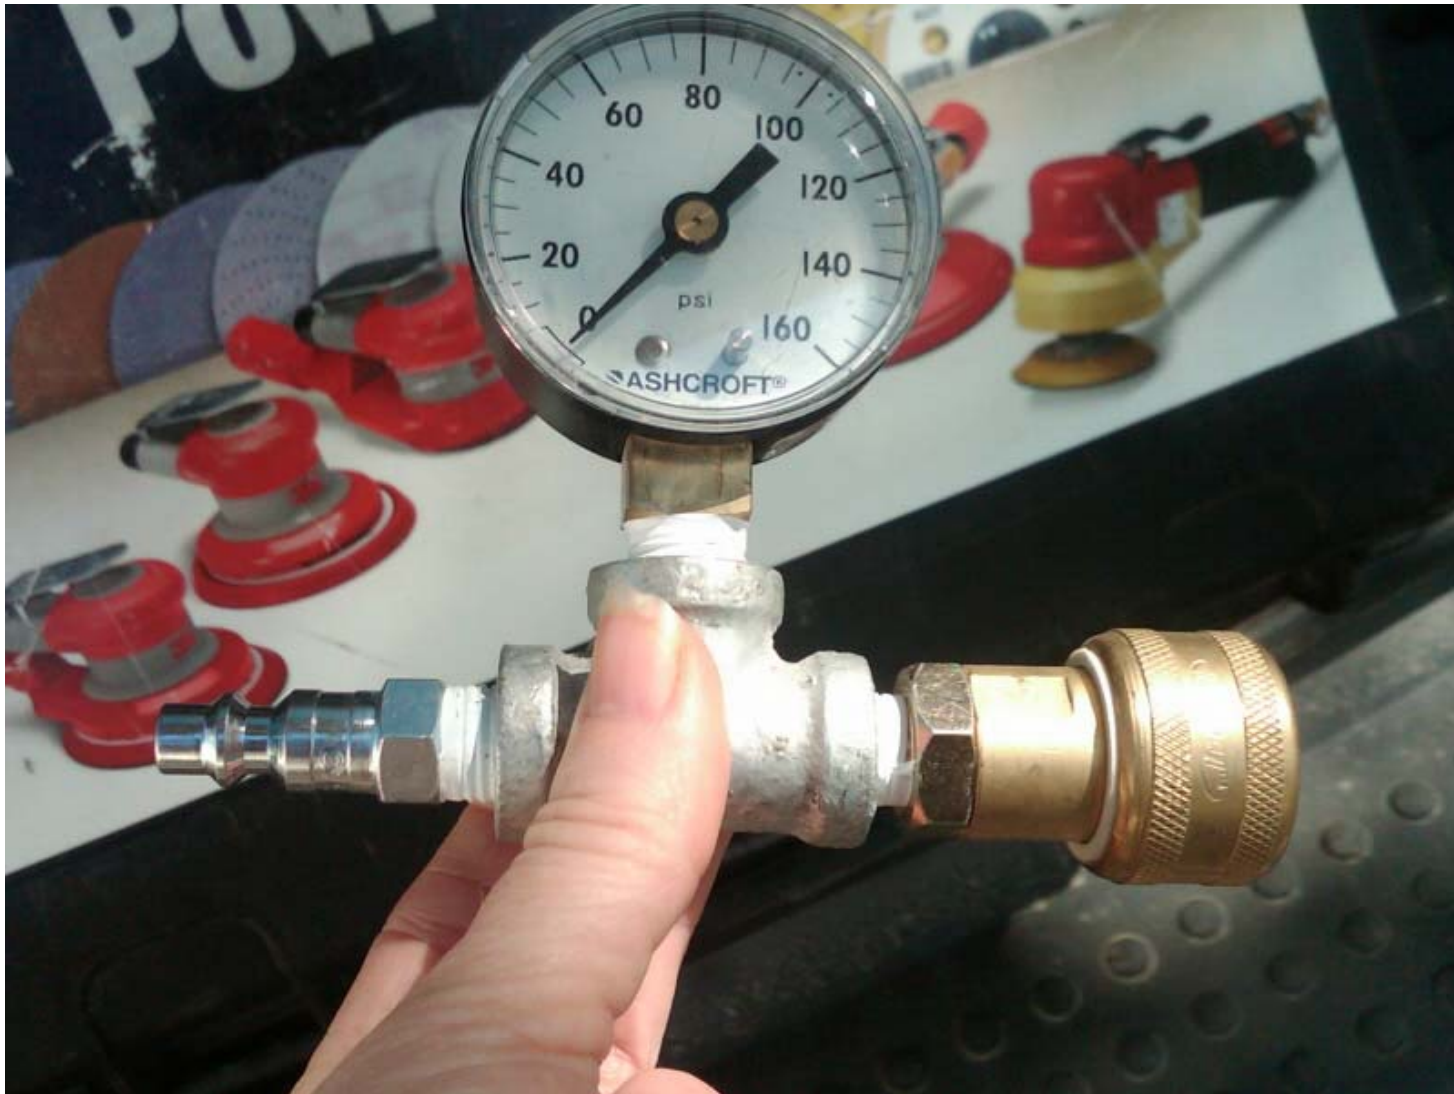
Tool for measuring shop air pressure
